Technical Bulletin

### Installation of tensioner used in PowerGrip® Kits K015543XS, K025543XS and K015559XS

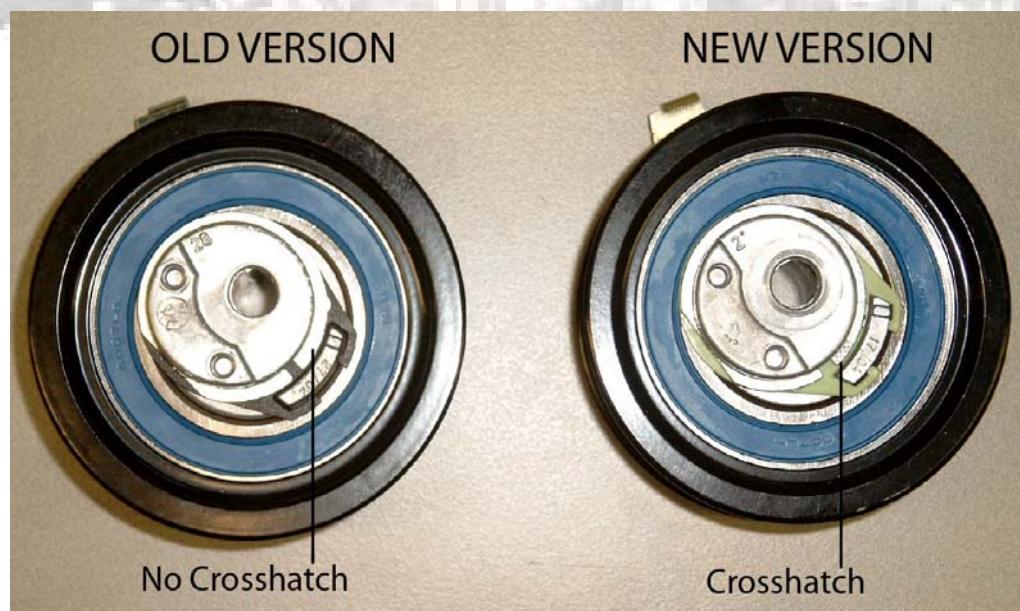
In Fig. 1 you can see that only the new version has a crosshatch belt wear indicator (see also Fig. 4). This section indicates when the timing belt is worn out and when it needs replacement.

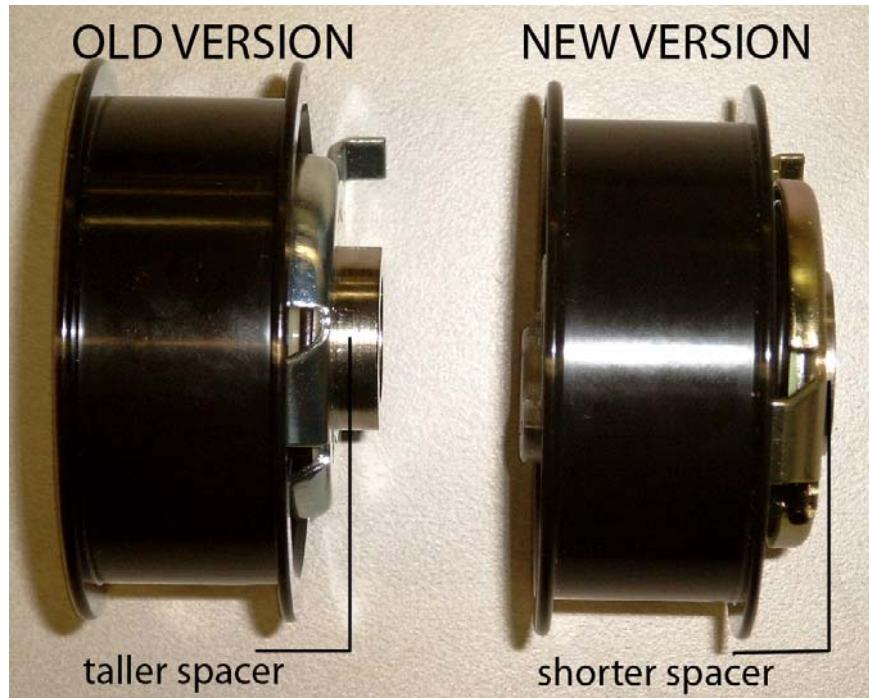
In Fig. 2 you can see that the new tensioner also has a shorter spacer. However, the distance between the engine block and the pulley remains the same.

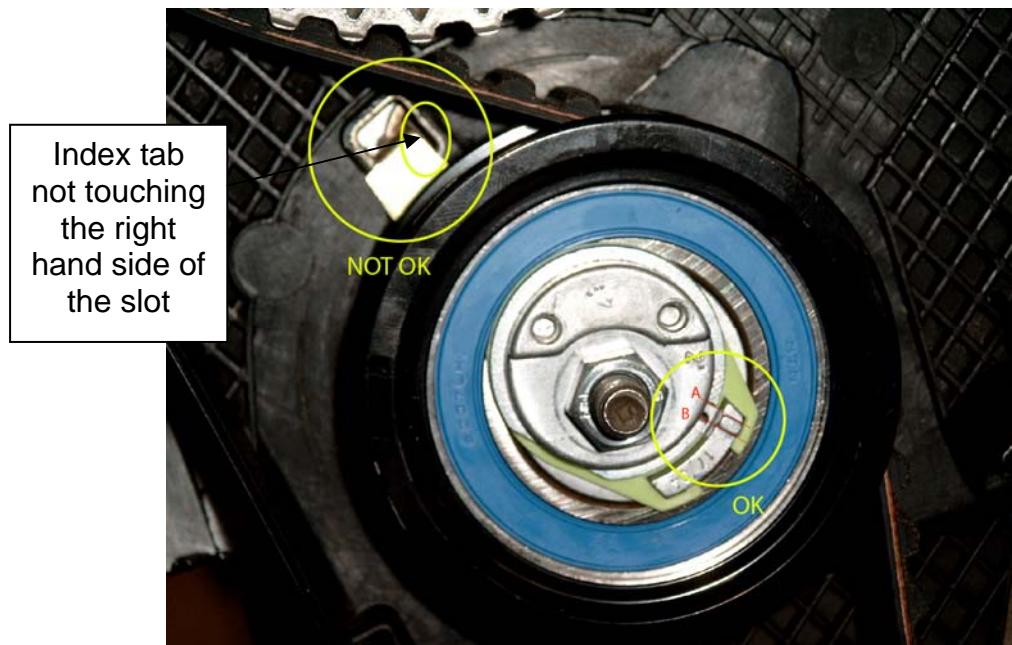
Fig. 5 shows one of the common errors. Pointer is perfectly positioned between lines A and B but the index tab is not OK. The index tab is in the slot but is not pushing against the right hand side of the slot. The reason for this is that the tensioner was moved anti-clockwise during the tensioning process.

If the pointer is not well positioned, the mechanic should restart the tension-setting procedure completely.

**When you are in the tension-setting, never turn the tensioner anti-clockwise!**

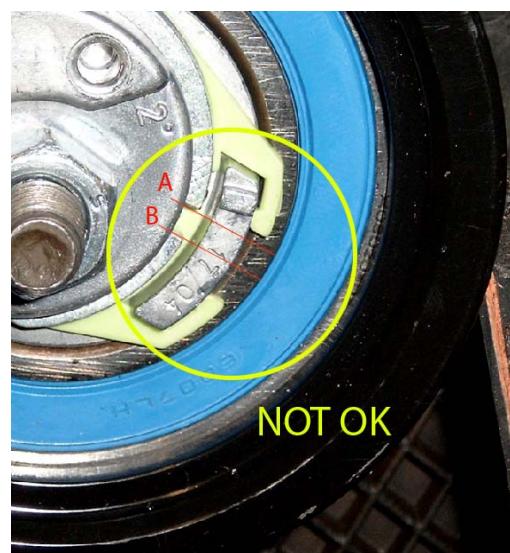
Fig. 6

A second possible error can be seen in Fig. 6. You can see that the pointer has not passed line A and is in front of the crosshatch. This means that the belt will have a too low tension.

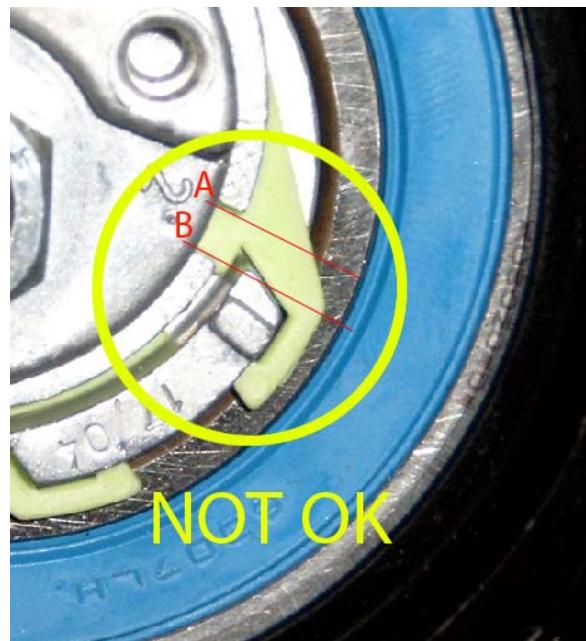
Fig. 7

A third installation error is shown in Fig. 7. The pointer has passed line B, this means that the belt will be tensioned too much.

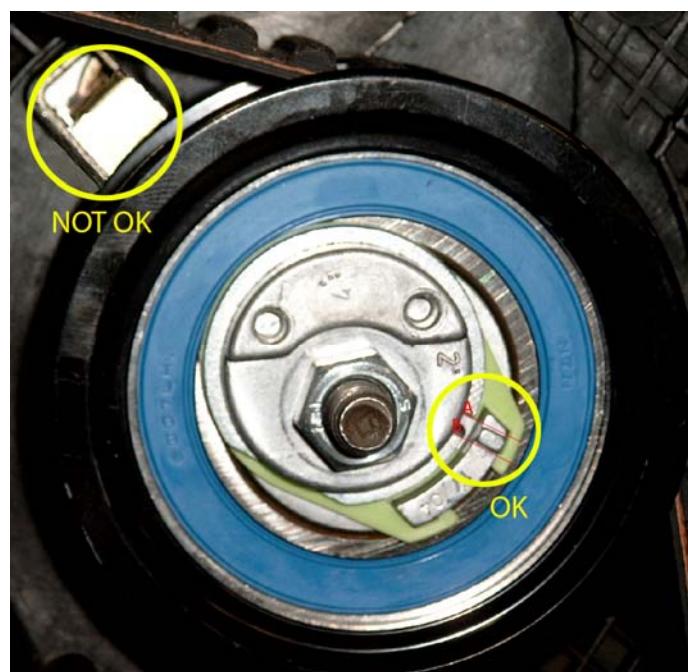
In Fig. 8 you can see a fourth error where the index tab is not locked in the slot although the pointer is perfectly positioned between lines A and B. This way the belt will lose its tension once in operation.

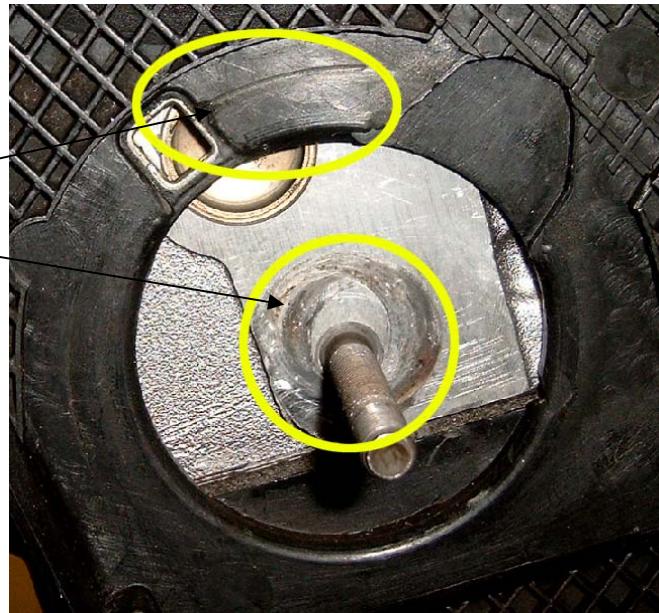
Fig. 9

You can see the marks on the engine caused by this type of wrong fitment in Fig. 9. In this case you will also see that the index tab on the tensioner is slightly bent over.

Marks on  
engine  
caused by 4<sup>th</sup>  
error type

**When the vehicle is released with a wrong positioned tensioner, severe engine damage will happen sooner or later.**

We can not stress enough how important it is to follow all the steps in the process of installing this tensioner without skipping one of them. It is better to lose 5 minutes at the installation then to lose an entire engine in the end.
